FY 2017 Status of Sodium Freezing and Remelting Tests

Nuclear Engineering Division

Q. Lv, E. Boron, Y. Momozaki, D. B. Chojnowski, J. J. Sienicki, and C. B. Reed
Nuclear Engineering Division, Argonne National Laboratory

September 15, 2017

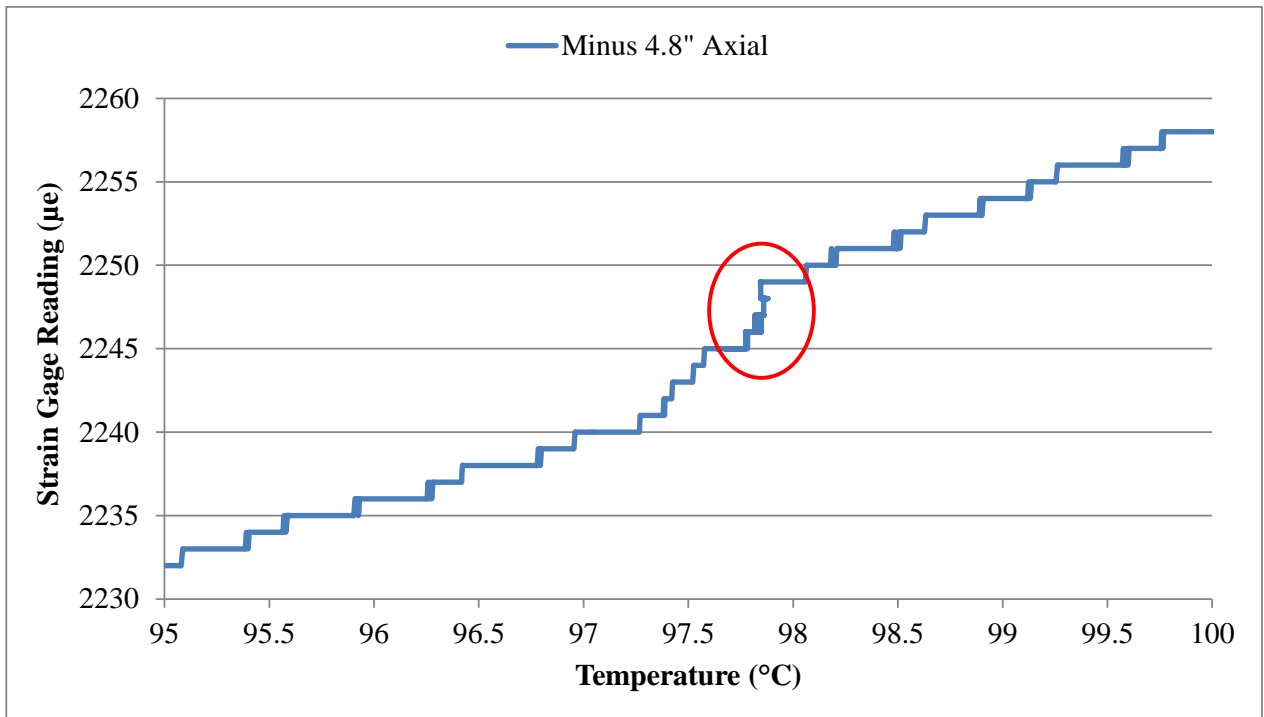
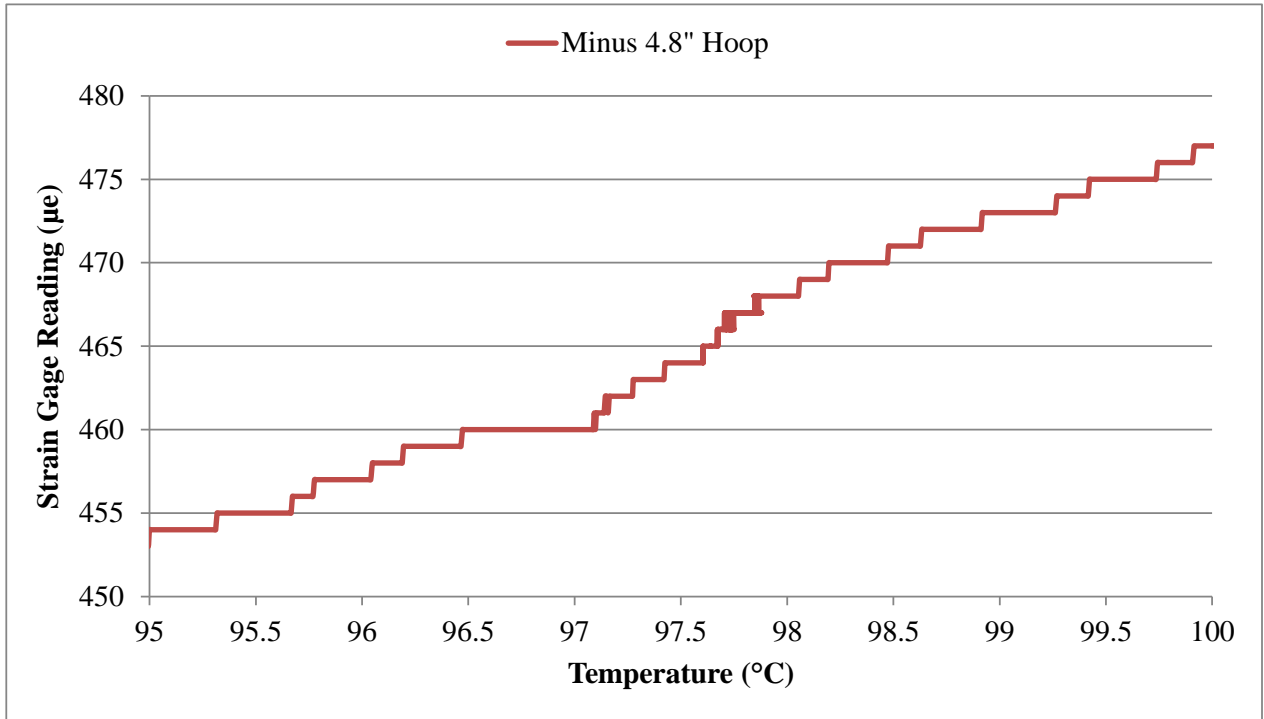
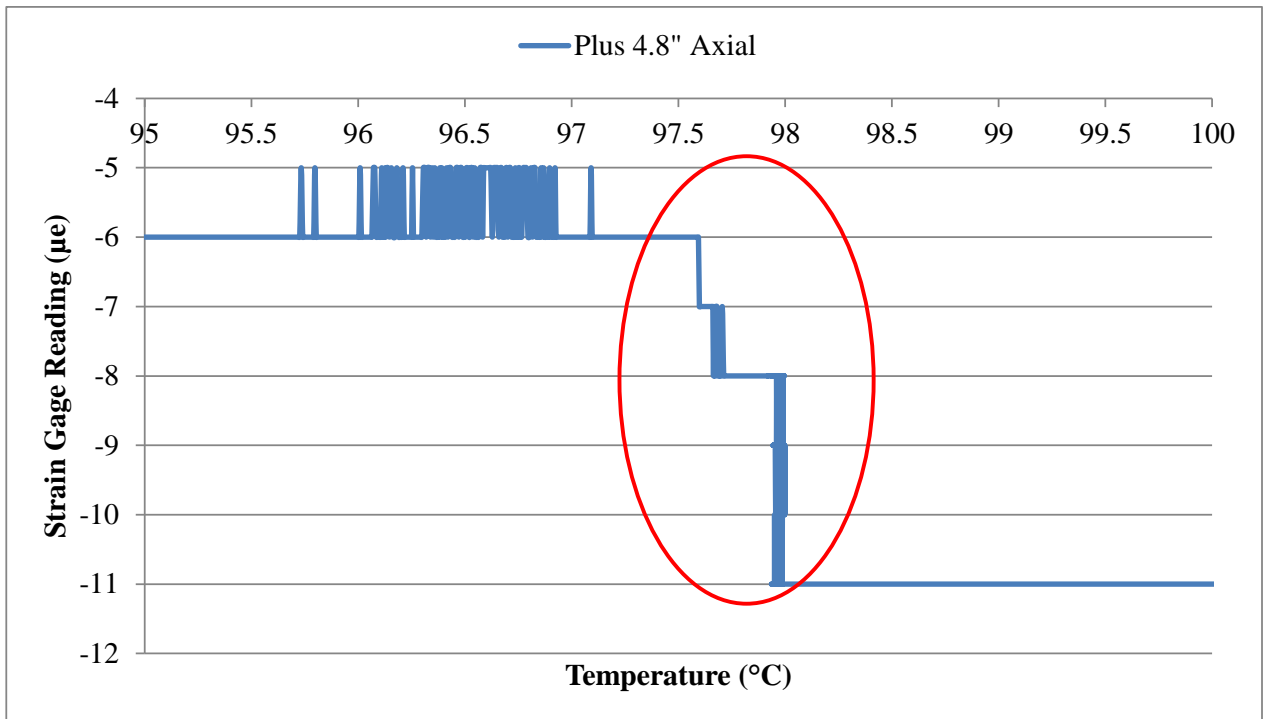
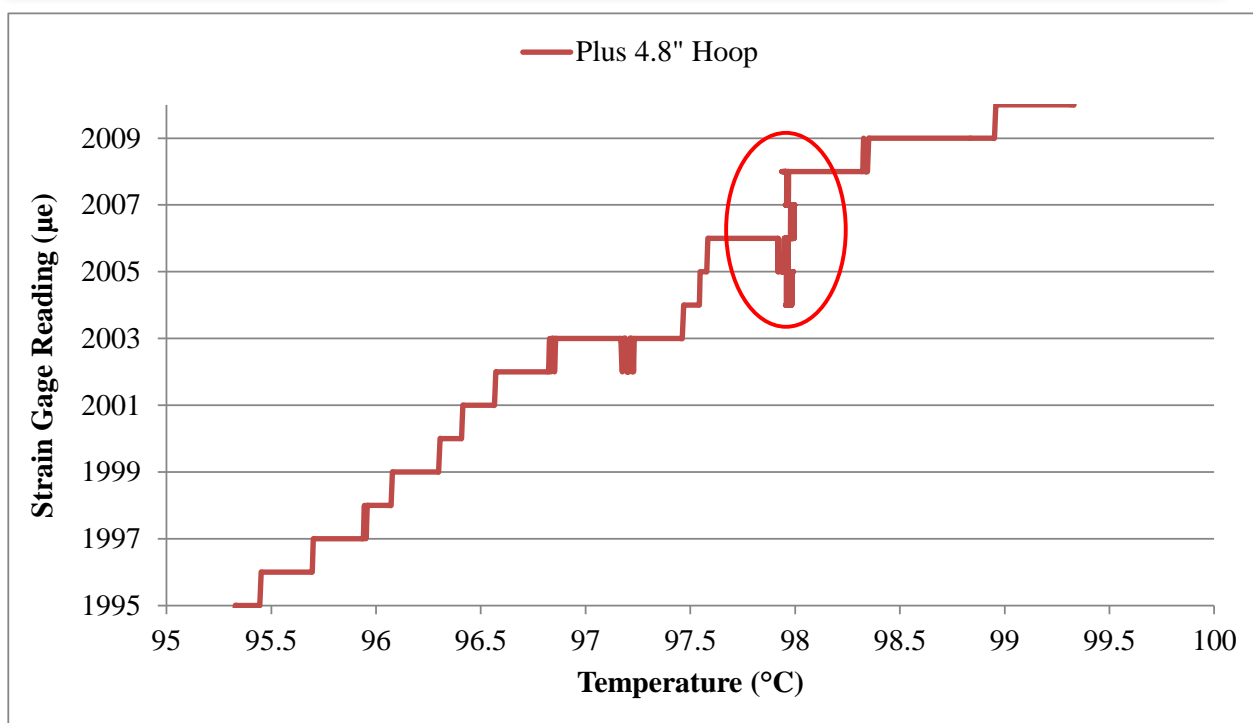
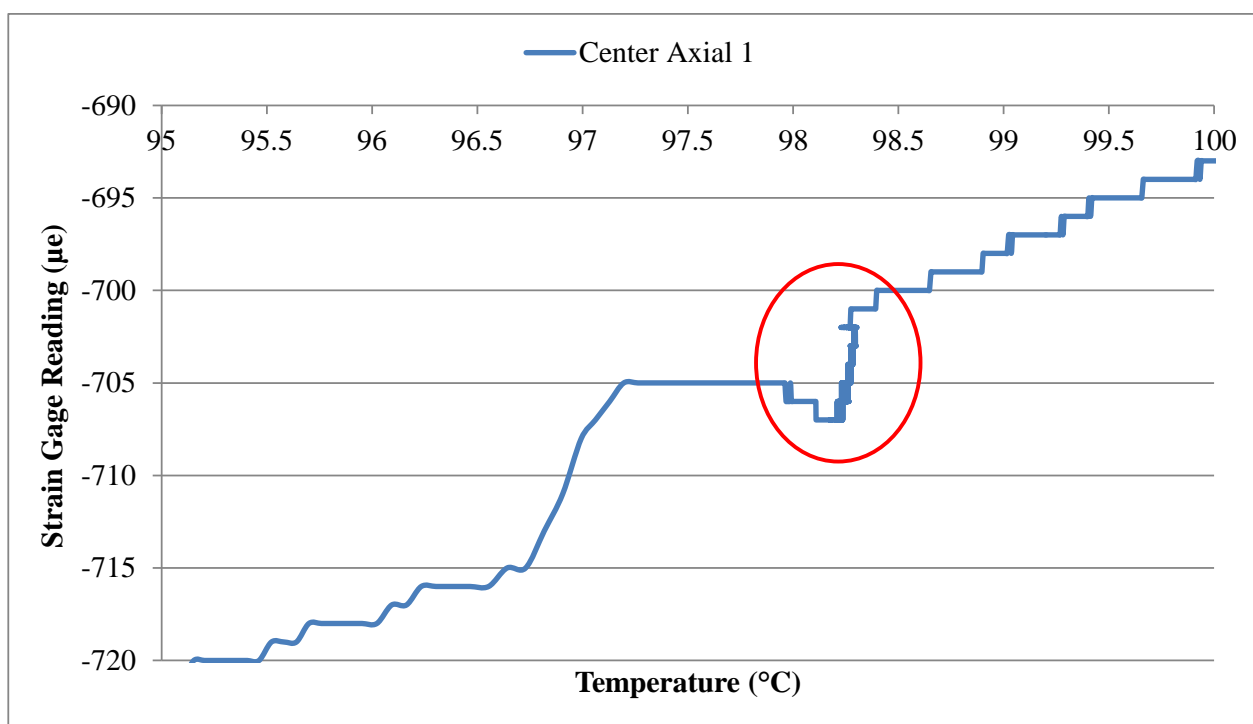
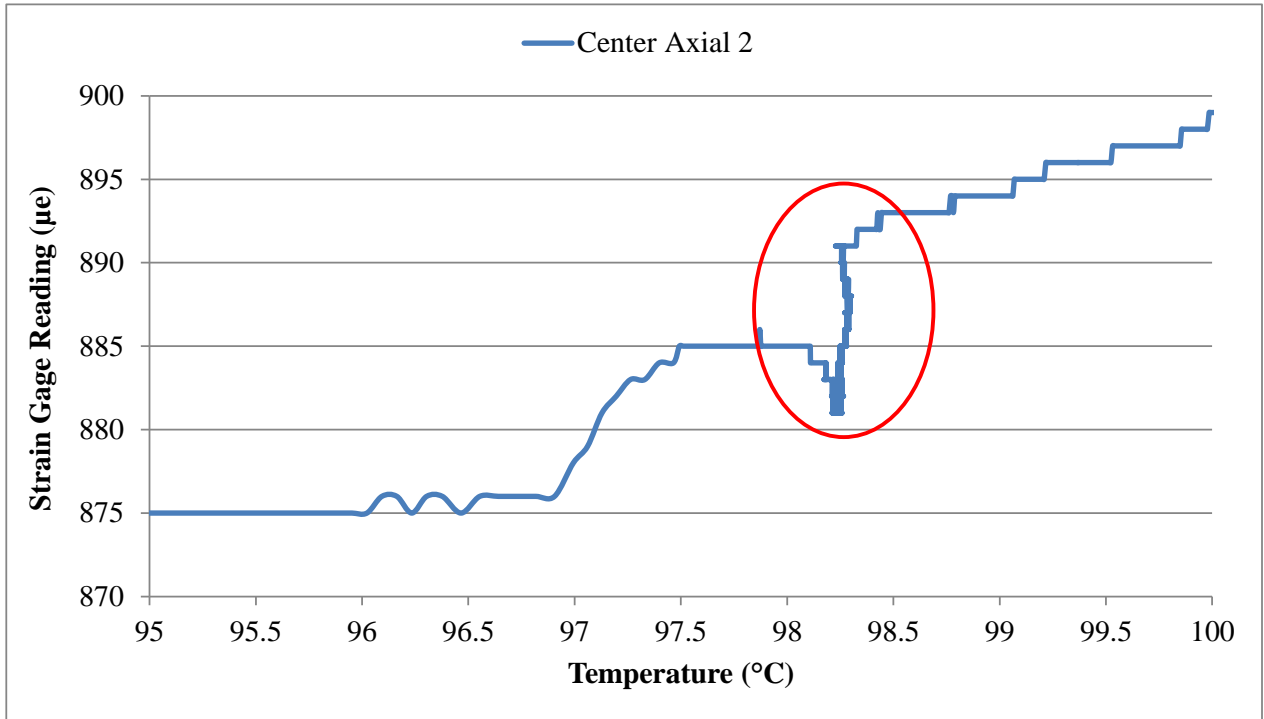
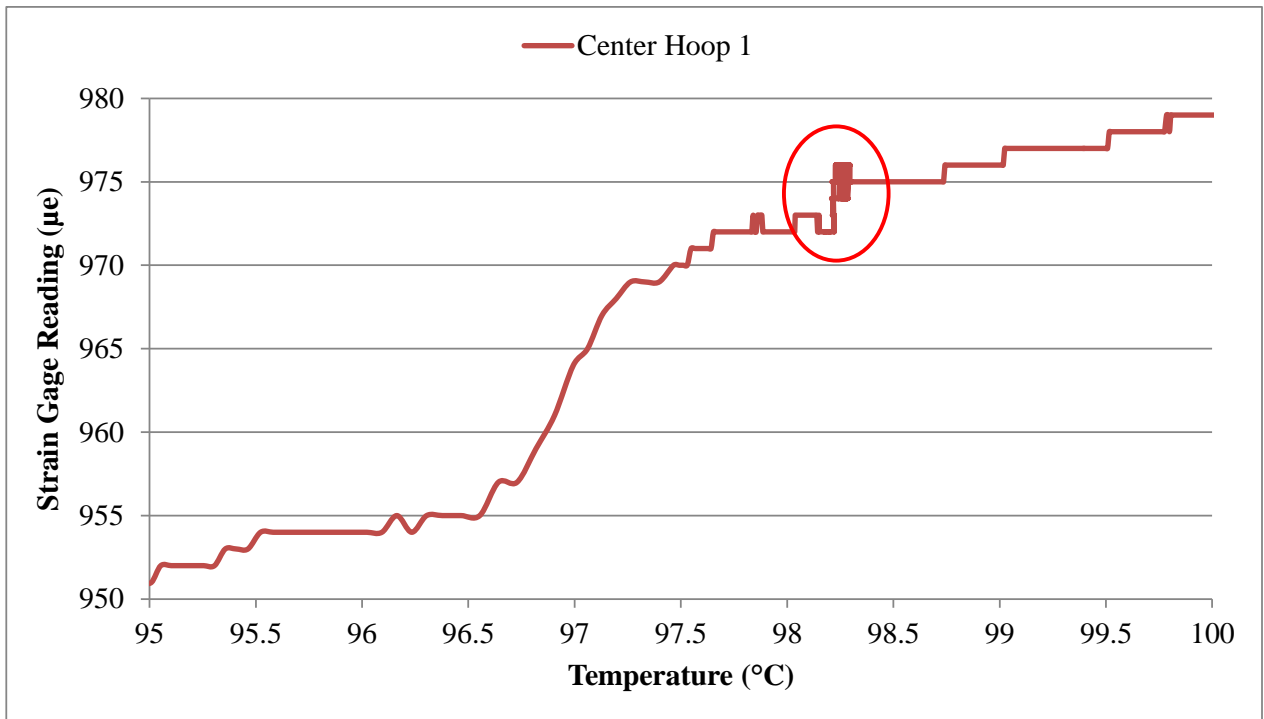
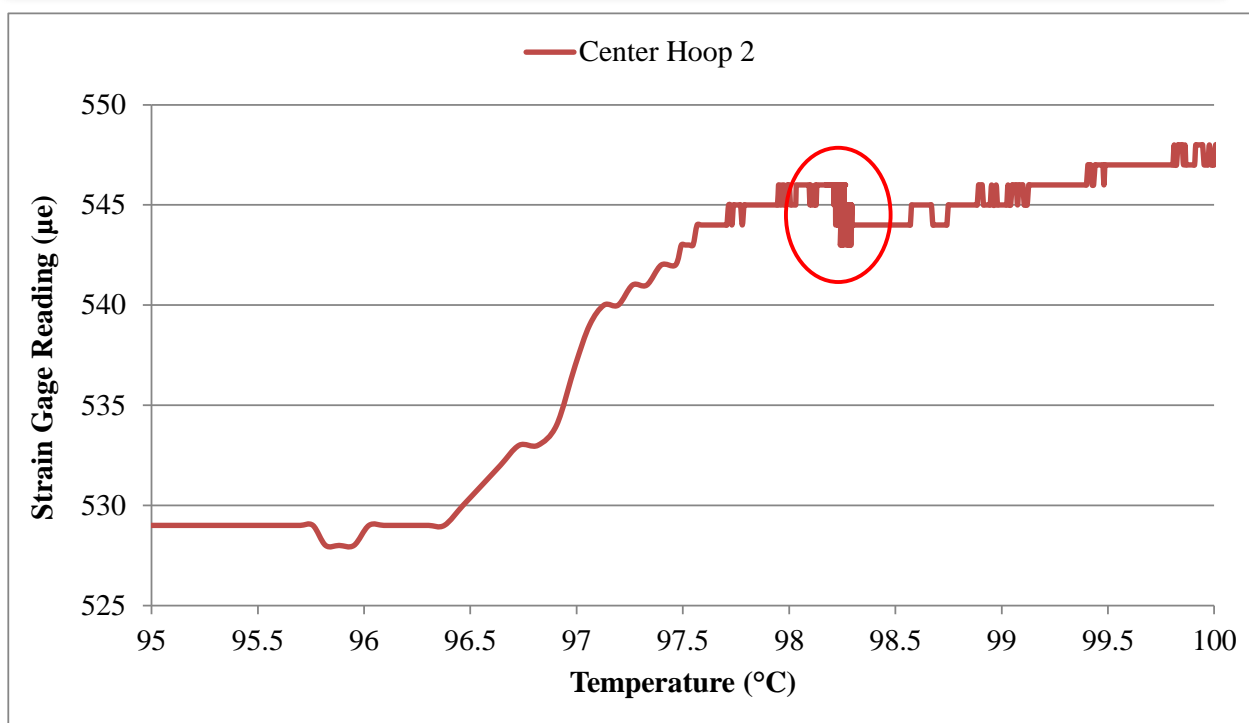
The measured test section strains at three different axial locations during sodium freezing are plotted against the corresponding average temperature at each location, as shown in Figure 38 - Figure 45. Among the 8 strain gages, the hoop strain gage at +4.8" location (Figure 41), two axial strain gages (Figure 42 and Figure 43) at the center, and one hoop strain gage at the center (Figure 44) clearly captured the pulling effect from the freezing sodium and the subsequent breakaway of sodium from the wall. When the sodium freezes, due to its contraction, the tube first experiences a drop in the strain. However, the test section was heated to ~ 400°C for only ~ 2 hours in the present test, which was not sufficient to reach a complete wetting of the test section inner surface. Therefore, the bonding between the frozen sodium and test section inner wall was not strong enough and eventually broke, causing an increase in the tube strain. The axial strain gage at -4.8" location (Figure 38) only captured the pulling effect from the freezing sodium; the axial strain gage at +4.8" location (Figure 40), and one hoop strain gage at the center (Figure 45) only captured the breakaway of frozen sodium from the wall; while the hoop strain gage at -4.8" location (Figure 39) did not capture anything. The maximum strain change measured in the present test is ~ 10 axial micro strains, corresponding to a negative pressure of only ~ 24 psi.

Figure 38. Axial strain vs temperature at -4.8" from the test section center

Figure 39. Hoop strain vs temperature at -4.8" from the test section center

Figure 40. Axial strain vs temperature at +4.8" from the test section center

Figure 41. Hoop strain vs temperature at +4.8" from the test section center

Figure 42. Axial Strain 1 vs temperature at the test section center

Figure 43. Axial Strain 2 vs temperature at the test section center

Figure 44. Hoop Strain 1 vs temperature at the test section center

Figure 45. Hoop Strain 2 vs temperature at the test section center
